Case Study

Roof Repair & Waterproofing: Deakin University

PROJECT: 221 BURWOOD HWY

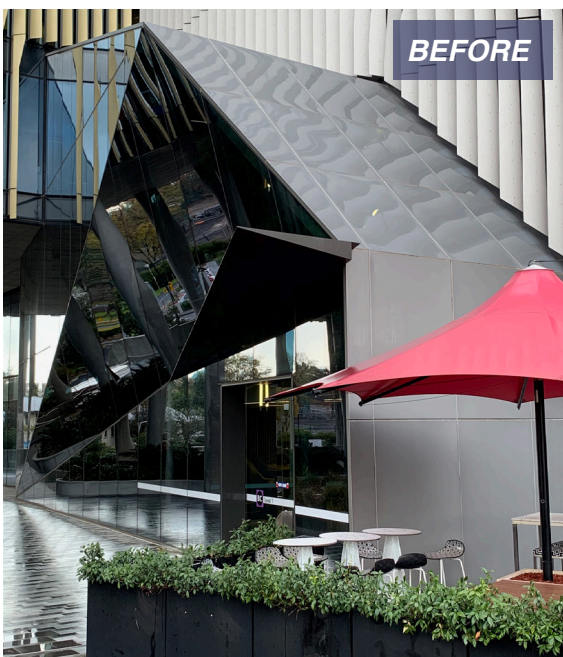
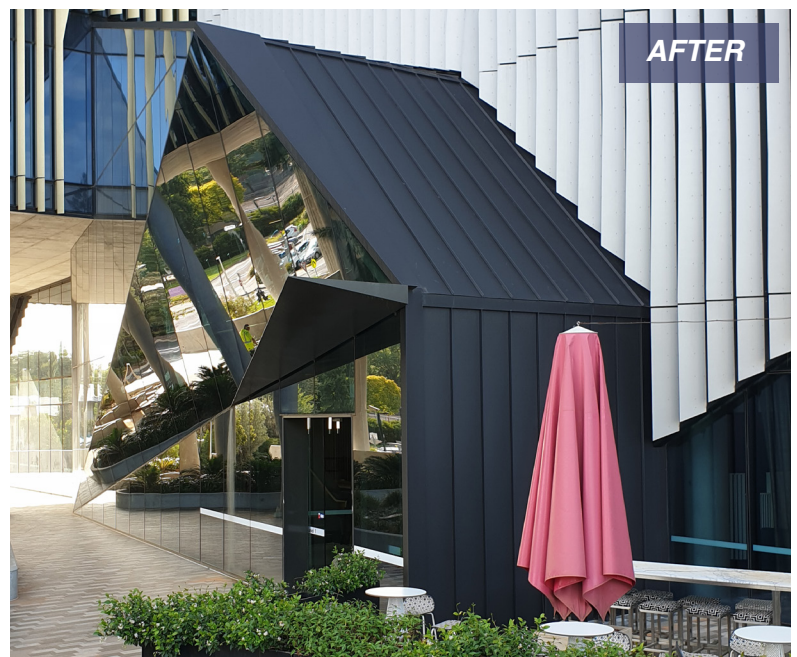
Reliable Plumbing Services collaborated with Deakin University's project team to deliver the scope, design and installation of a turnkey solution for a longstanding waterproofing issue at the BC Building, Burwood Campus. The building's canopy was leaking due to a compromised installation of the existing Alucobond sheets and silicon materials.

"The project was complex due to the height of the external roof which covered a protruding stair well over three levels." - Senior Project Officer, Deakin University

After a thorough analysis, and consultation with the university, our solution was to install high-performance Colorbond cladding over the top of the existing Alucobond. This would not require the use of silicon and would prevent further water egress and subsequent water damage to the building. The project also involved complex scaffolding and working with ropes to safely access and install the new cladding on the steep pitch of the canopy.

- Complete turnkey solution, from initial assessment to project delivery.
- Duration: 4-5 weeks.
- Building purpose: Corporate Centre.
- 180m² of Alucobond roof & associated flashing removed & replaced across 3 different sections of canopy.
- Materials used: Colorbond flashings and sheets, Esteam panel.
- Effective site safety procedures implemented in a 3 story building.
- There have been no issues or complications since project completion.
